# Effects of Degradation in Textolite Elements of Damaged Surge Arresters

Hubert Śmietanka <sup>1</sup>, Przemysław Ranachowski <sup>2</sup>, Zbigniew Ranachowski <sup>2,\*</sup>, Krzysztof Wieczorek <sup>3</sup> and Stanislav Kudela, Jr. <sup>4</sup>

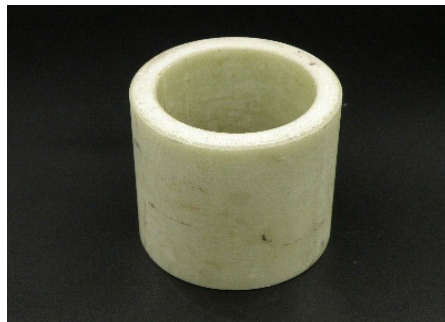
**Figure 1.** Textolite bushing support that came from an operated 110 kV surge arrester. Due to the lack of any degradation effects, the element was taken as a reference sample.

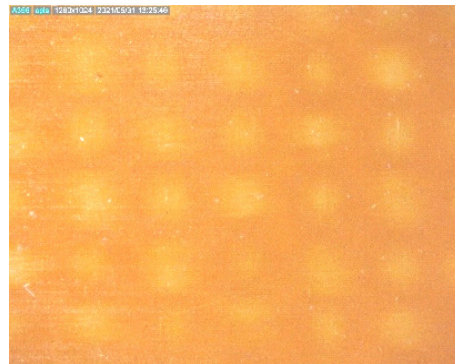
**Figure 2.** MO image of the surface of the reference sample textolite material (40 times magnification). The lighter weave of the support fabric is visible as fibreglass under a transparent resin layer.

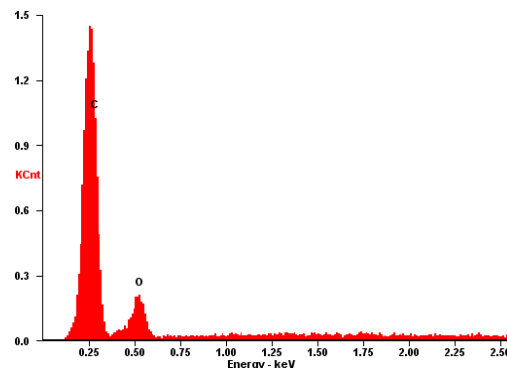
**Figure 3.** Typical EDS spectrum recorded for the surface of the reference sample textolite material. Only carbon and oxygen were present, which were derived from an organic epoxy resin. They represented 71.5% and 28.5% by weight, respectively.

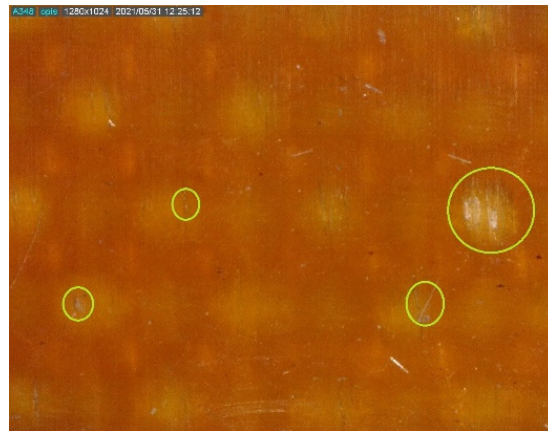
**Figure 4.** MO image of the textolite material's surface with initial degradation effects (40 times magnification). There was a visible change in the colour of the material, indicating the process of carbonisation of the organic resin. Small fragments of the fibreglass textile support began to appear on the surface (marked in circles).

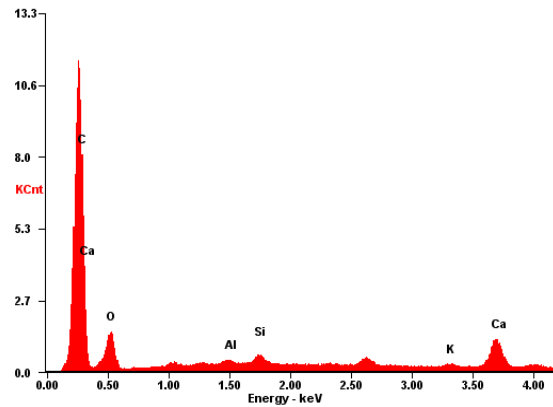
**Figure 5.** Typical EDS spectrum registered for the textolite material with slightly marked degradation effects. There was already a low content of fibreglass support elements, namely, silicon (Si), calcium (Ca) and aluminium (Al), at the levels of 1.1%, 2.4% and 0.4%, respectively.

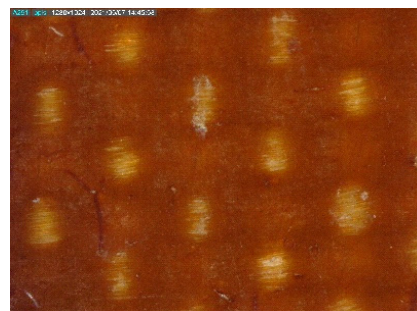
**Figure 6.** MO image of the surface of the textolite material with clearly marked degradation effects (40 times magnification). Shiny bundles of fibres of the textile support are visible. They appeared on the surface of the material after the top layer of the resin had melted.

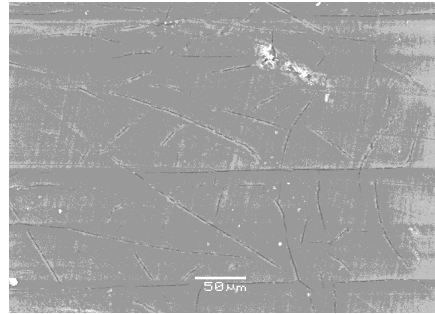
**Figure 7.** SEM image of the textolite material surface with clearly marked degradation effects at a high magnification of 300 times. A network of small cracks in the resin surface is visible.

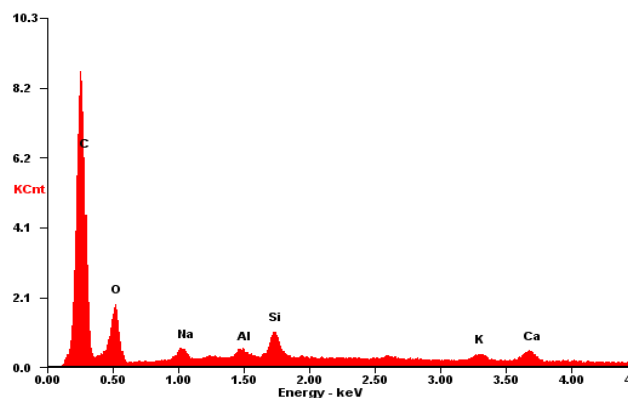
**Figure 8.** The EDS spectrum recorded for the textolite material with evidently marked degradation effects. The contents of the elements present in fibreglass textile support (silicon, calcium, aluminium, potassium and sodium) are clearly visible.

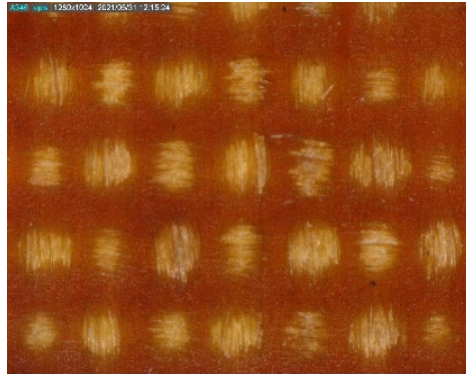
**Figure 9.** MO image of the surface of the textolite material with advanced degradation effects (40 times magnification). Significant carbonisation of the organic binder of the sample material occurred. Numerous bright fibre bundles of the textile support are visible. After the top layer of the resin had melted, the fibre bundles were found on the laminate surface.

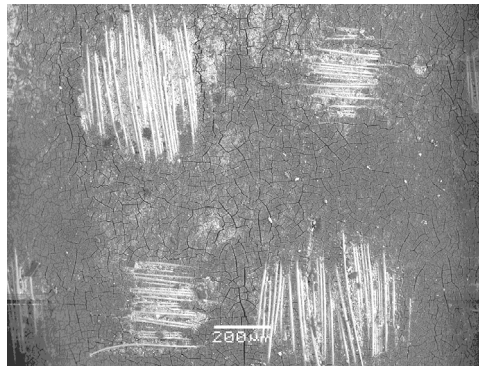
**Figure 10.** SEM image of the textolite material surface with visible degradation effects (75 times magnification). In addition to the light bundles of fibres of the textile support, there was clear cracking of the top layer of resin.

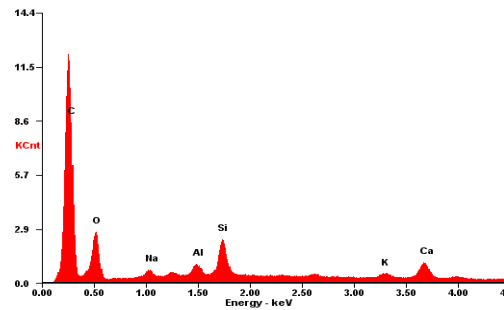
**Figure 11.** A typical EDS spectrum registered for the textolite material with advanced degradation effects. On the surface, there is a significant share of the elements present in the fibreglass support, namely, silicon and metals.

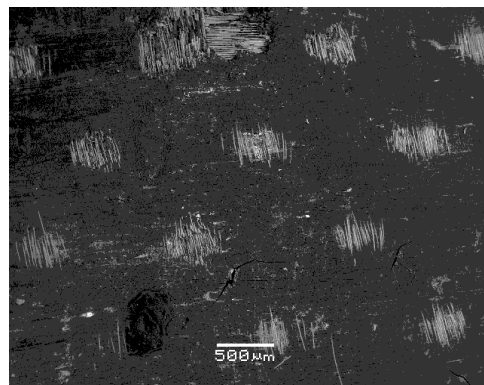
**Figure 12.** SEM image of the surface of the textolite material with strong degradation effects (30 times magnification). There is a large amount of charring and melting of the resin visible in the top layer of the material and numerous bundles of bright fibres of the textile support on the surface. There were also single large cracks in the resin.

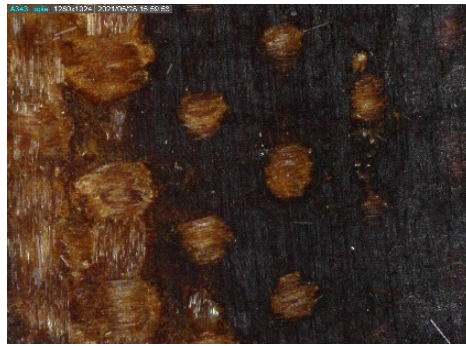
**Figure 13.** MO image of the surface of the textolite material with intensified degradation effects (40 times magnification). The edge part of the textolite element is visible, in which a strong charring and burning out of a fragment of the top layer of the resin took place. On the left side, at the edge, the exposed textile support is visible.

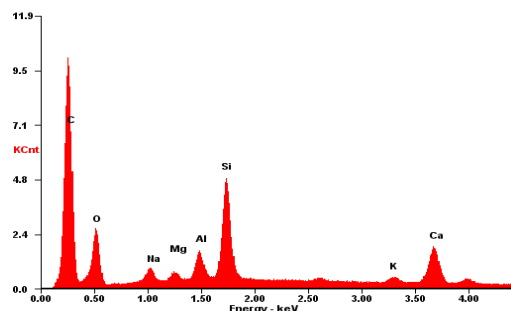
**Figure 14.** Exemplary EDS spectrum recorded for a textolite material with enhanced degradation effects. The contribution of the elements present in the fibreglass support, especially silicon, calcium and aluminium, was important. Oxygen was present in both the organic and the amorphous phases.

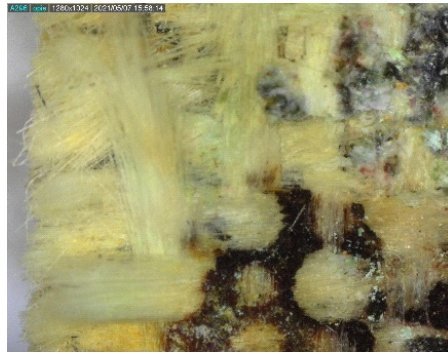
**Figure 15.** MO image of the marginal part surface of the textolite support, which was heavily degraded (40 times magnification). In the immediate vicinity of the edge, the resin had been almost completely burned out; the exposed textile support is visible.

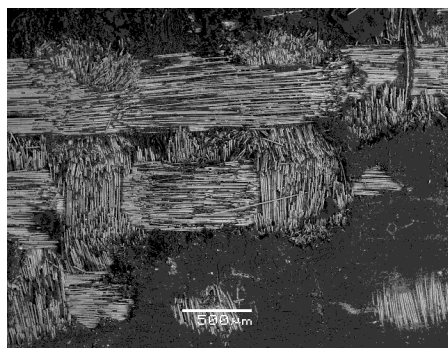
**Figure 16.** SEM image of the surface of the textolite material with very strong degradation effects (40 times magnification). The resin on the top layer of the material had been largely melted, charred and burned out. In the visible textile support, the fibre bundles were damaged and moved.

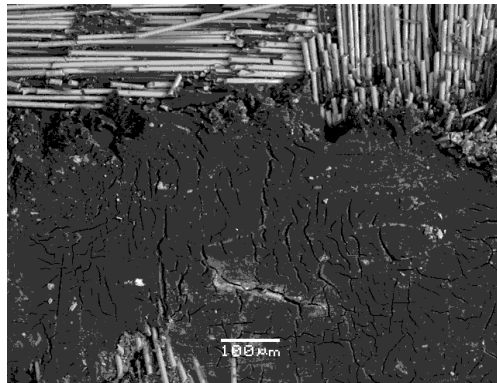
**Figure 17.** SEM image of the textolite surface with very strong degradation effects (150 times magnification). Strong cracking of the carbonised resin and damage to the glass fibres in the textile support is visible.

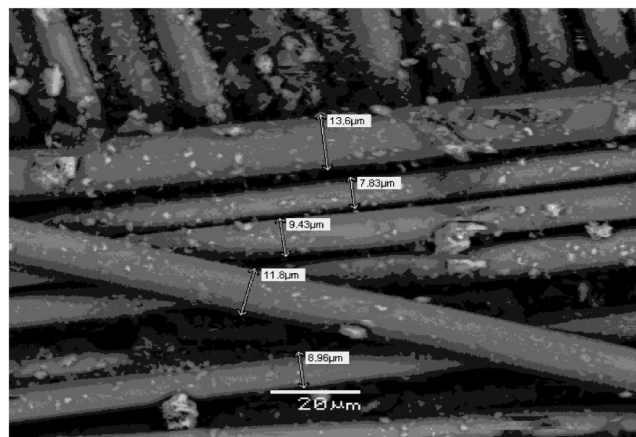
**Figure 18.** SEM image of the surface of very badly damaged textolite material (magnified 900 times). Exposed textile support glass fibres are visible, and on their surfaces are the remains after the destruction of the organic phase.

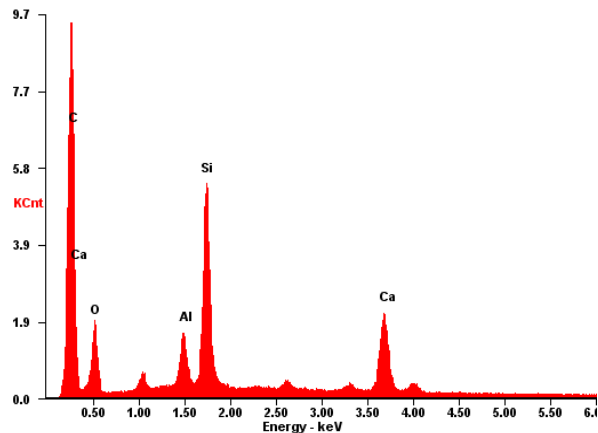
**Figure 19.** Exemplary EDS spectrum recorded for a textolite material with very strong degradation effects. The results for the sample with a significant amount of highly charred and cracked epoxy resin on the surface. There was a large share of elements present in the glass support, i.e., silicon and metals. Oxygen was present in both components of the laminate.

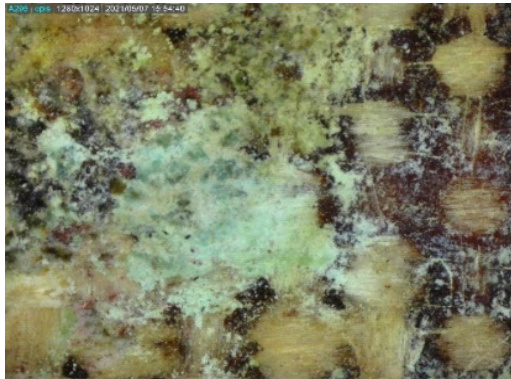
**Figure 20.** MO image of the surface of a textolite material with a greenish deposit of copper compounds and very strong degradation effects (magnified 40 times). Strong charring of resin residues on the surface of the sample material is visible.

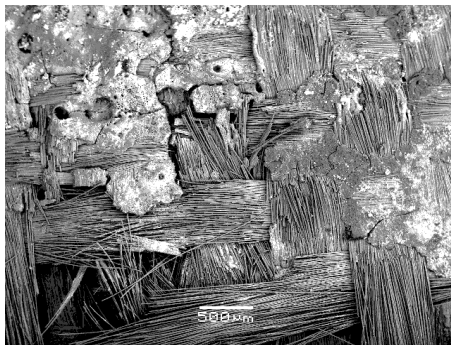
**Figure 21.** SEM image of the surface of the textolite material with a copper compounds sediment and very strong degradation effects (magnified 35 times). The resin on the top layer of the material was almost completely charred and burned out. Damage to the textile support is visible. There were cracks and characteristic cavities in the sediment layer.

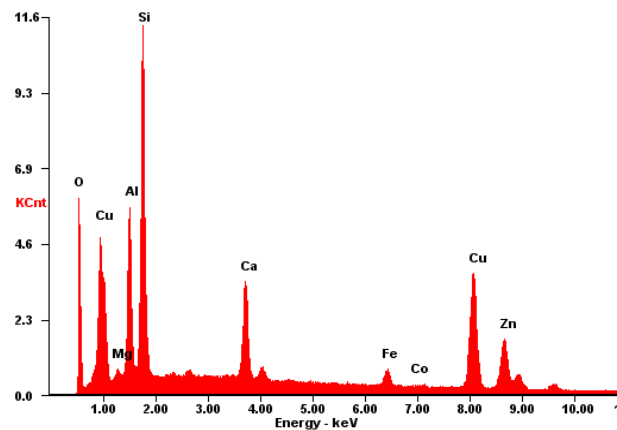
**Figure 22.** Exemplary EDS spectrum registered for a fragment of a textolite material with sediment made of copper compounds and very strong degradation effects. Copper was present from the sediment layer, along with elements from the glass support.
